# Automation in Transportation Accidents

Deborah Bruce

National Transportation Safety  
Board

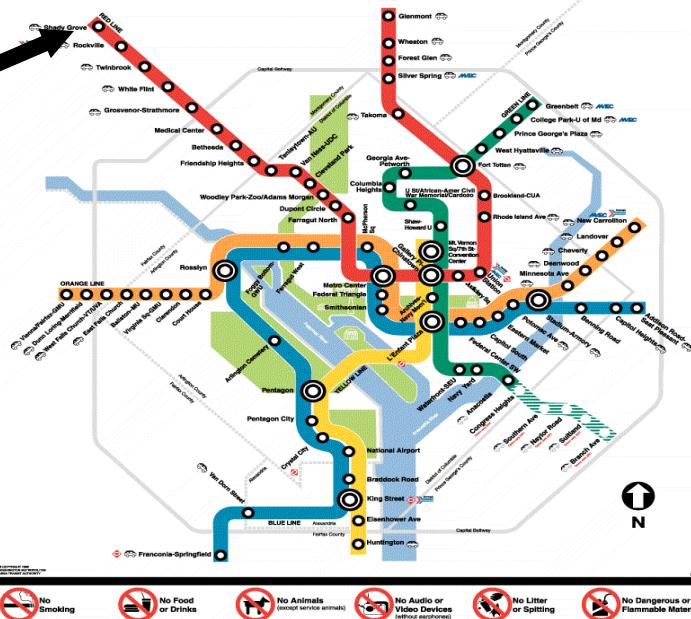
# Metro train

- Controllers instructed the train to continue Automatic mode, set speed at lower performance level (59 mph).
- Train overruns Twinbrook Station (told by controllers not to service station go to next in Automatic mode).
- The train then overran Rockville Station by one car. Results in *performance level* loss because the train was not within platform limits.
- Thus, the train departed to Shady Grove Station at 75 mph (rather than 59 mph). Train overran station by 470 ft, struck and telescoped 21 feet into standing train.

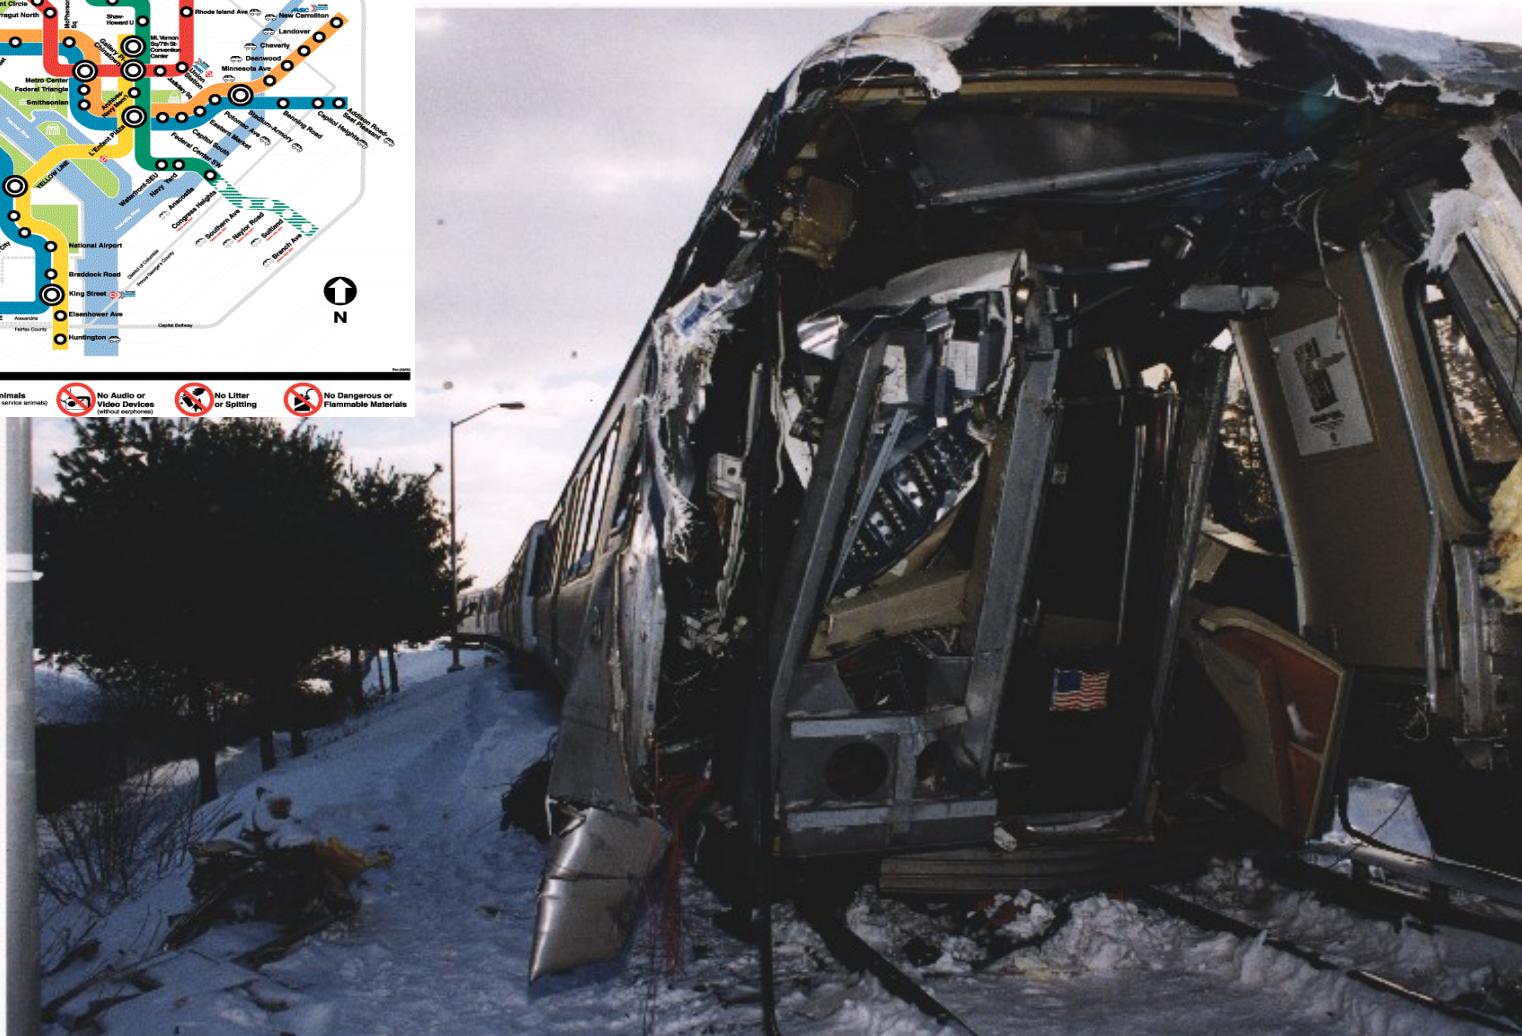
# Accident Sequence

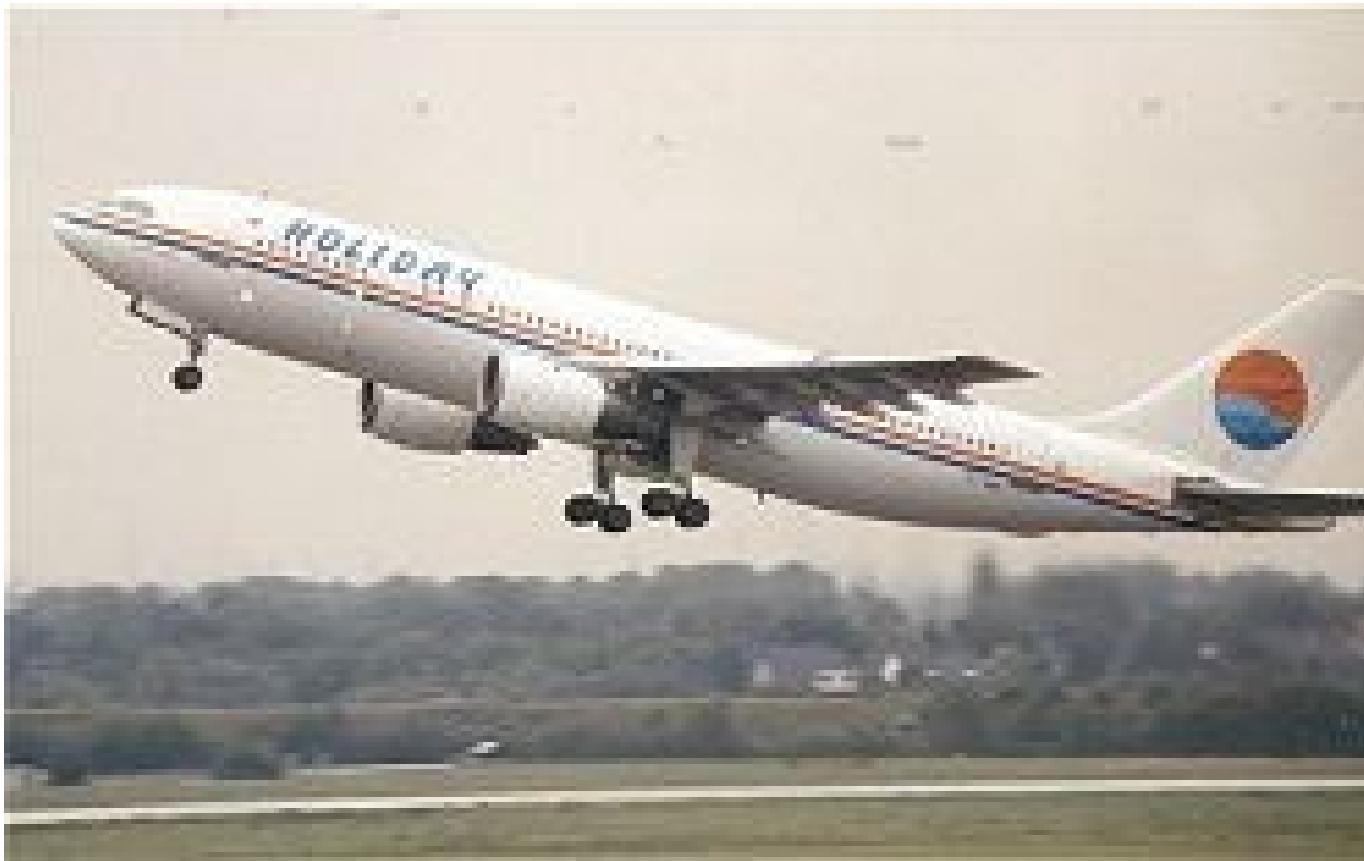
# A300-600 Inflight Upset

- Autothrottle set to hold 210 knots
- Engaged at start of descent from FL240
  - During descent - power reduced from idle to mechanical stops
- Not engaged at level off at FL160
- Airspeed decreased
- About 170 knots flightcrew advanced throttles
- Stall warning activated and upset occurred
- No evidence of autothrottle malfunction
